Rear Axle Failure Analysis of the Dump Truck

Faizin Adi Nugroho^{a*}, Sri Nugroho^b, Mohammad Tauviqirrahman^c

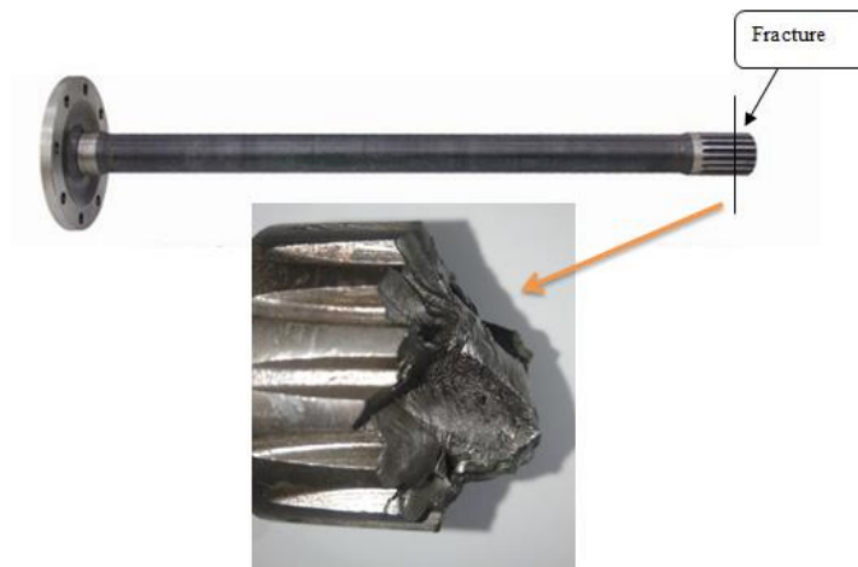
Figure 1: The Broken of the Axle Shaft whos Connected with a Differential Gear

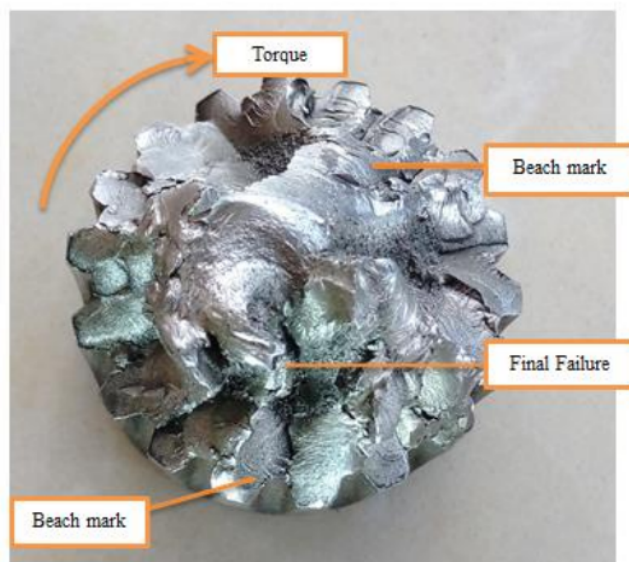
From the results of the macroscopic analysis it is seen that the crack initiation on the shaft starts from the edge of the shaft towards the center of the shaft as evidenced by the shape of the spiral in the center of the shaft that has failed. In the figure 2 there is a beach mark that is evenly distributed from the edge to the center of the shaft and the combination of slow crack propagation (dull and fibrous areas) and rapid crack propagation (areas that are shiny and slippery) indicates the shaft accepts dynamic loads.

Figure 2: Cross Section of Broken Shaft

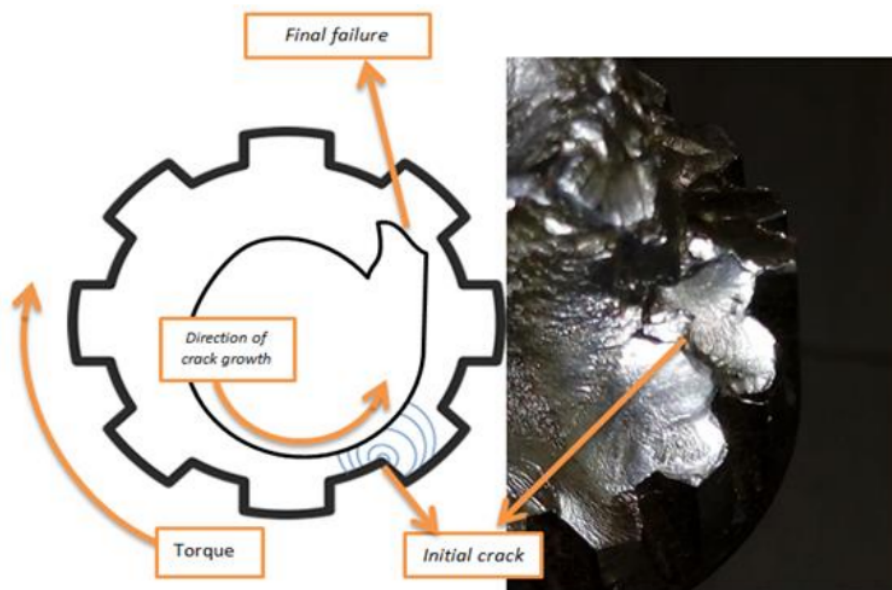
The crack initial is indicated by striation and beach mark in the area around the crack initiation at the fault edge and appears to be rougher, while the beach mark is indicated by fine semi-circular lines in the initial crack area to final failure. Beach marks also called to be crack propagation stages. The area between the crack propagation stage and the final stage can quantitatively show the magnitude of the stress acting. If the area of the crack propagation area is greater than the area of the final fracture, the working stressing is relatively low, and vice versa if the area of the crack propagation is smaller than the area of the final fracture, the working of the

Figure 3: Initial Crack and Direction of Crack Growth

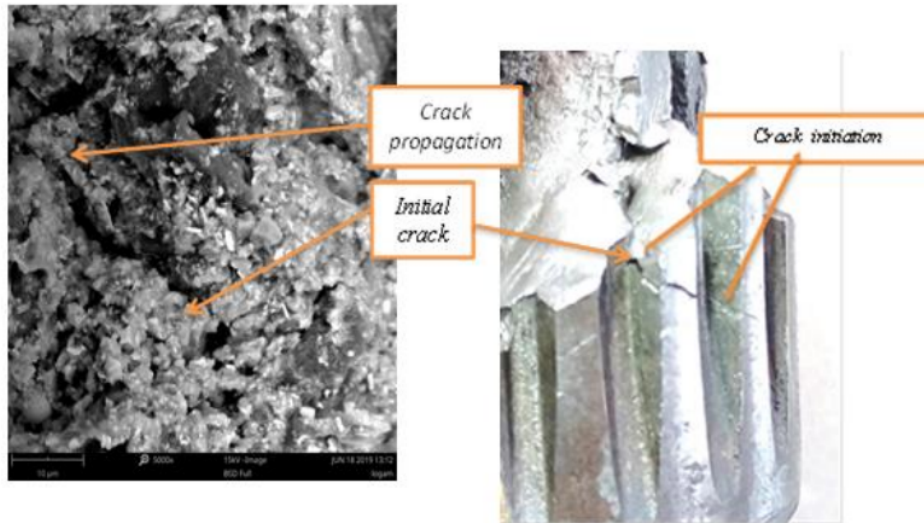
Figure 4: Crack Initiation and Crack Propagation

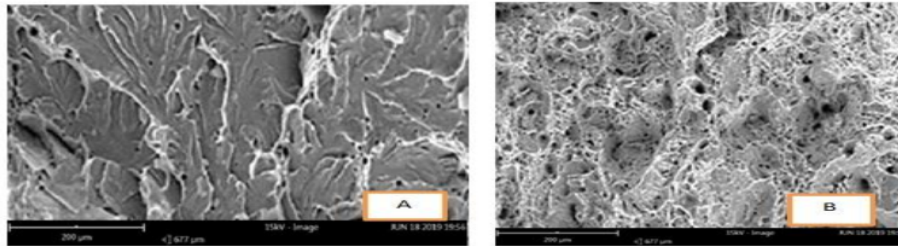
Fractography on the surface of the shaft can be seen as a V-shaped cleavage on the surface fracture, certainly broken because on brittle mode. While the fracture on the core of the shaft shows the shape of the dimples on the fault. Ascertained is an elastic type of fault. The fracture surface assessment identified several characteristics of fatigue failure characteristics: (i) a beach mark sign that is a sign of development of fatigue front cracks and (ii) a ratchet mark which is a sign of crack initiation due to high stress concentration. The exact mechanism of fatigue is always consistent with unidirectional bending. Eg: [6]

Figure 5: (A) Fractography analysis of the edge of the failed component; (B) fractography analysis of the core of the failed component.

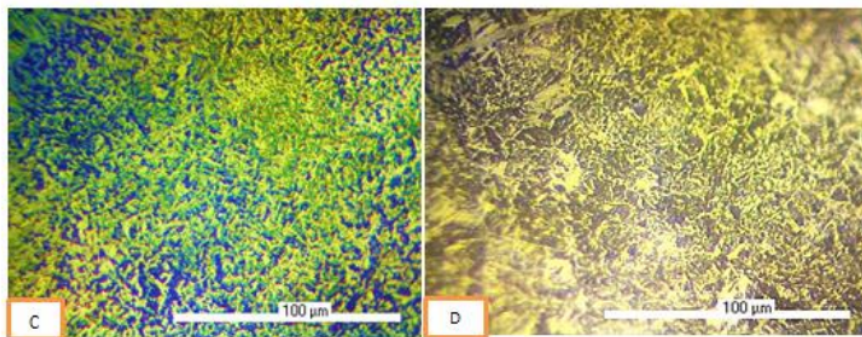
Figure 6: (C). Microstructure of the edge of the component 600x, (D). Microstructure of the core of the component 600x

Microscopic analysis on the shaft surface, Figure 6 C and 7 C, show that the martensite phase is uneven tends to be grouped. There is a ferrite-pearlite phase on the sidelines of a martensite group, indicating the temperature at the surface hardening process is unstable. The matrix area shows that the dominant martensite phase is rough and sharp so that it can be concluded that tempering is carried out at high temperatures and quite a long time and is quenched quickly. This grouped and uneven martensite phase results in uneven surface hardness of the shaft.

Analysis of the core of the shaft, figure 6 D, show the dominant ferrite and pearlite phases. It was concluded that the core of the shaft was more resilient than the surface of the shaft which was dominated by the hard bainite and martensite phases.

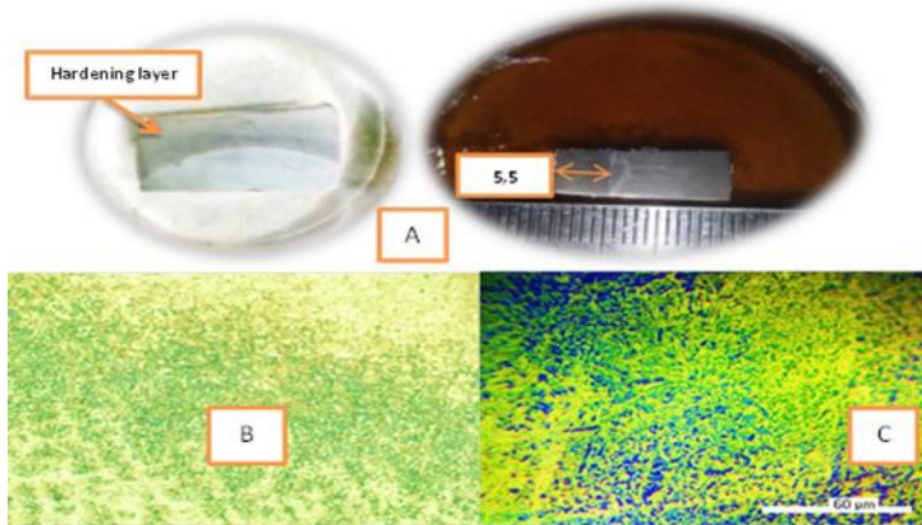
Figure 7: (A). Macrostructure of the cross section of the failed shaft, (B). Microstructure of the edge of the component 50x, (C). Microstructure of the edge of the component 600x

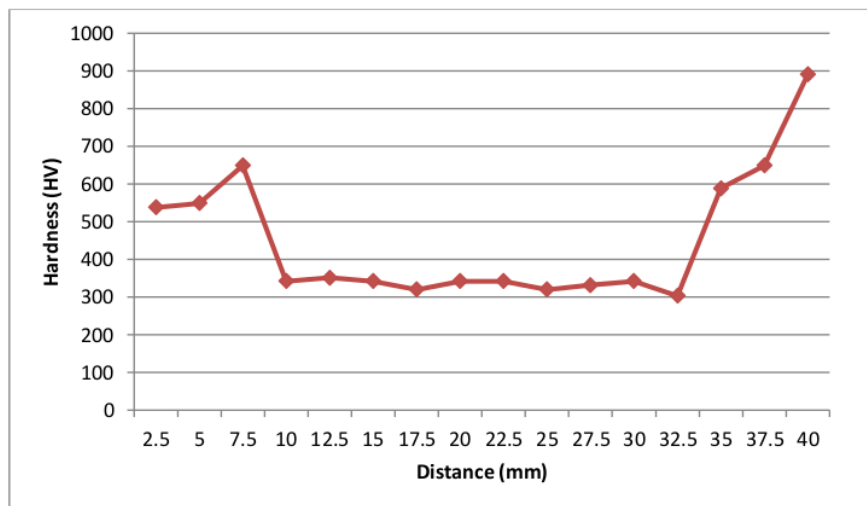
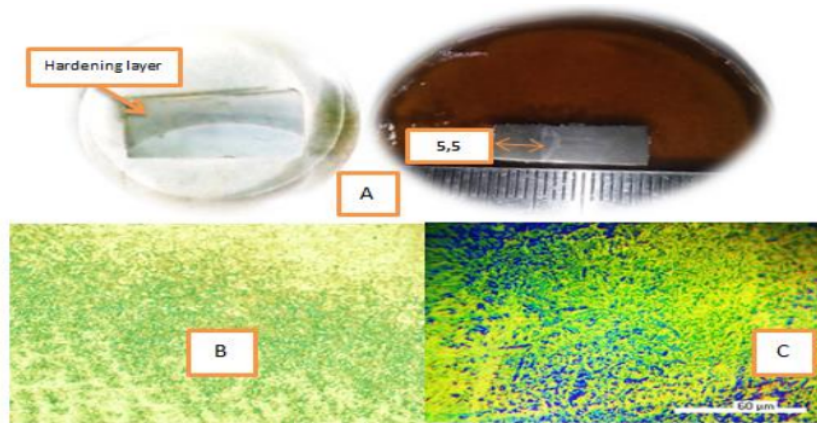
Figure 8: Rear Axle Hardness Distribution A

The distribution of the hardness values observed in Figure 8 does not look uniform. Surface hardness on different left and right sides is different, namely 538 HV and 891 HV indicating that surface hardening is not evenly distributed on the shaft. The distribution of the hardness value observed in Figure 9 There is a fluctuation in the value of hardness which is tested 2 mm from the edge (surface) by 40 circular points using a Vickers hardness tester. The highest hardness value is 885 HV and the lowest is 548 HV.
