Failure Analysis Of Water Pump Shaft

Didik Ariwibowo*, Sulthonul Putra, Seno Darmanto, Juli Mrihardjono, Wiji Mangestiyono

Mechanical Design Engineering, Industrial Technology Departement Vocational School of Diponegoro University
Jl. Prof.Soedarto, SH. UNDIP, Tembalang, Semarang, 50275, Indonesia

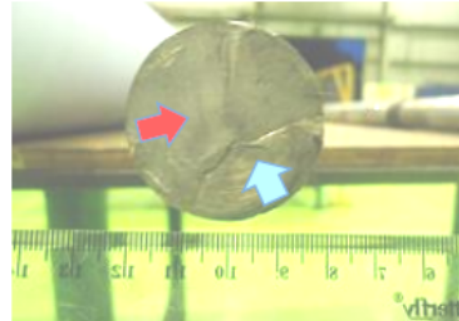
Visual inspection was carried out to analyze the modes of failure. One of the picture can be seen at Fig.2. This leading to hypotheses that shaft failed in torsion loading condition. The figure shows that there is a crack initiation. This mode of failure was consider that shaft sustained a rotational load that cause the tensile stress over its ultimate strength. This initial crack was mis-inspection. From historical maintenance data, the shaft was not checked for it.

Figure 2 also shows that the fracture plane was perpendicular to the longitudinal plane of the shaft. It was indicated that crack propagation occurred under induced flexural fatigue loading.

Figure 2. Modes of failure: a. initial crack portion (lower arrow), and b. failure portion (upper arrow)

There are three portion area of the failure, portion that large plastic deformation occurs (large portion), portion of brittle fracture, and portion of rotational bending fatigue characteristic. A large portion of the failure surface was flattened and smeared off. This surface condition was considered due to a repeated grinding against the fracture surface with mating part while the motor runs after complete fracture. The fatigue occurs because of pump operation over 40000 hours without preventive maintenance.

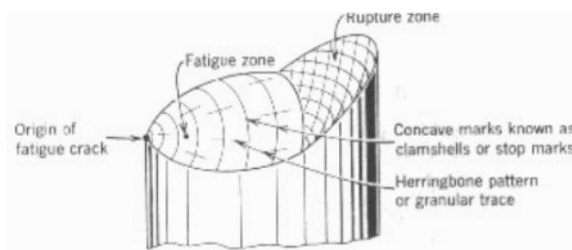
Figure 2 shows that there also was a fatigue zone. The fatigue zone can be described as follows: a smooth rubbed, and velvety appearance, the presence of waves known as "clamshells" or "oyster-shells", "stop marks" and "beach marks," and the herringbone pattern or granular trace which shows the origin of the crack, as seen at Fig3 [6]. In general, stop marks indicate the variations in the rate of crack propagation due to variations in stress amplitude in a cyclic application varying with time.

Figure 3. Failure zone

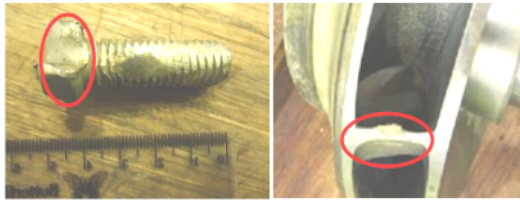
The cause of the over tensile strength was of the foreign material, those are sand and bolt in pump chamber. The bolt that found in the chamber and damage of impeller can be seen at Fig.4. The rotation of shaft was stucked by the bolt, cause tensile stress increased in the shaft over its tensile strength. The initial crack extents until shaft

broken. Besides the stucked, imbalance that cause of bolt exerted in impeller could also be contributor of shaft failure. It can also be seen that their direction of initial crack and failure was different. This is caused by maintenance activity that change the vertical position of the shaft. This failure phenomena is similar to that in pump shaft failure studied by some researcher [2, 3, 4, 5].

Figure 4. Bolt in pump chamber and damage of impeller

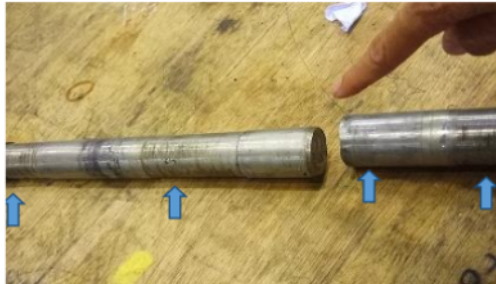
Another cause of failure was worn out of shaft at bearing location, that can be seen at Fig. 4. This wear cause the shaft cross section area reduced and lack to withstand tensile stress. The stress is a high stress level of induce fluctuating stresses that exerts from a start and stop cycle mode of operation. The shaft experiences cyclic flexural load and torsional load during pumping operation. At this location, an excessive plastic deformation could be induced and severe localized stress occurs. This would lead to fatigue crack. The mass of shaft is an factor that induce cyclic flexural stress. This stress is distributed uniformly along the length of the shaft between the bearing supports. At the bearing support, reduced cross section area induces a local stress gradient then this stress could be the contributor to failure of the shaft. The fillet corner was too sharp to withstand the stress concentration for longer duration.

Figure 4. Shaft cross section area reduction caused by wearing out of bearing bushing
