The Soft Story Challenge to Architectural Design in Earthquake-Prone Areas

Livian Teddy* & Gagoek Hardiman

ABSTRACT

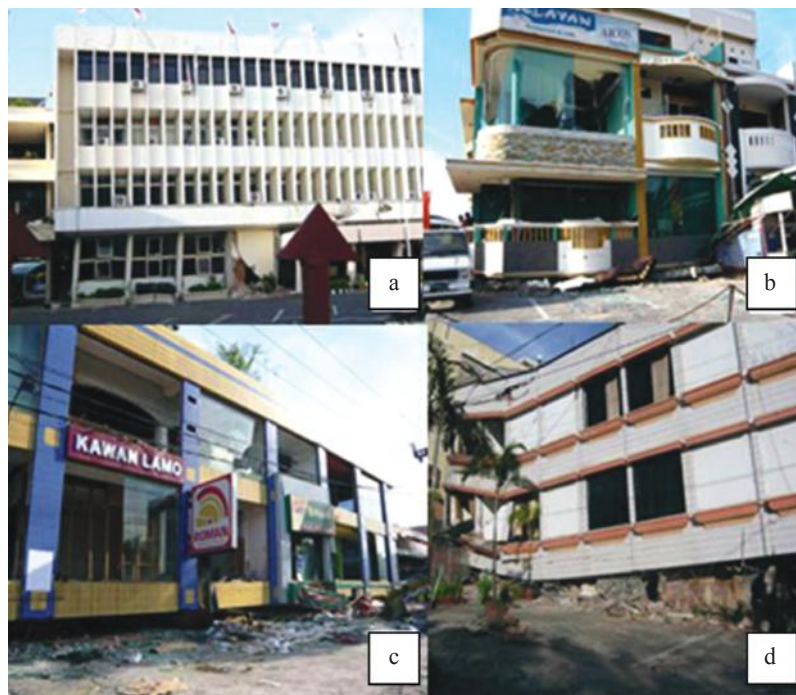
FIGURE 2. The Padang earthquake on September 30 & October 1, 2007: a). The Office of DPU Padang experienced a soft story on the 1st floor but it was still survived, b). The shophouse 3 stories experienced severe a soft story at the 1st floor. This floor collapsed, and the 2nd & 3th floors fell on it, c). & d). The commercial building experiencing a severe soft story at the 1st floor. This floor collapsed, and the 2nd & 3th floors fell on it (source: <http://www.perencanaanstruktur.com/2010/10/bentuk-keruntuhan-bangunan-saat-gempa.html>).

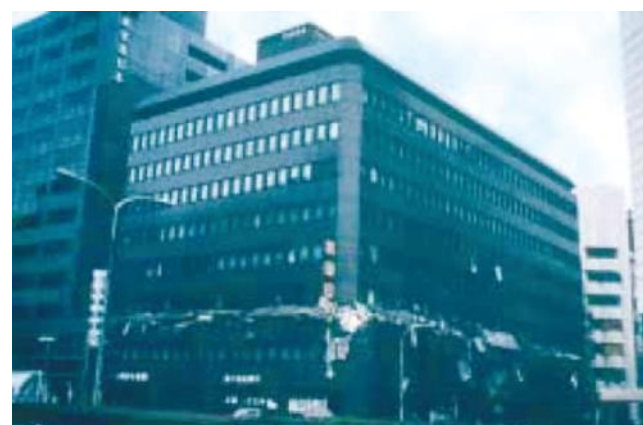
Soft stories often occur on the first floor, but they may also occur at any floor provided the stiffness of a floor is the weakest compared to other floors (Figure 4).

FIGURE 4. The Kobe Earthquake of 1995, the third story of the commercial building was lost and the above stories fell on it (source: Bachmann 2003).

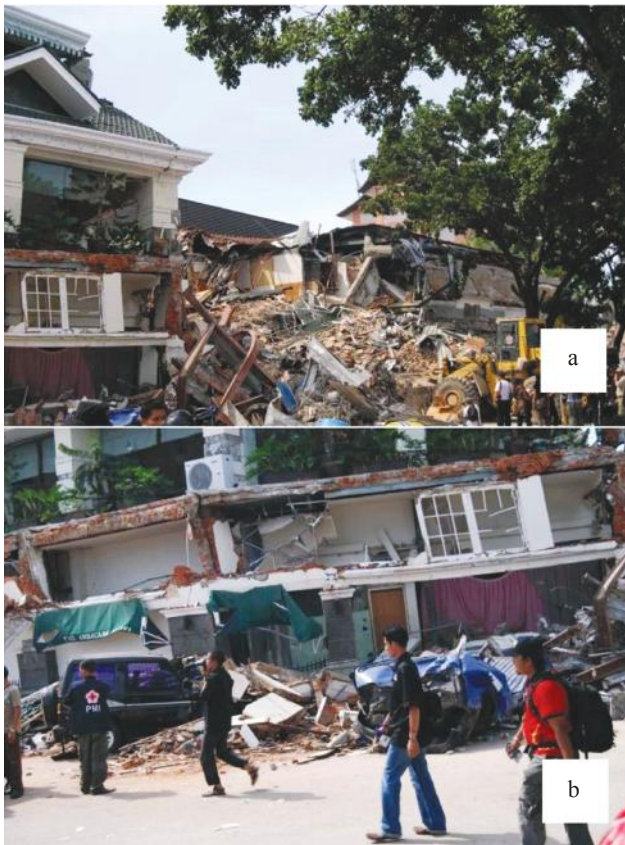
One of the most controversial cases was the collapse of Hotel Ambacang that killed 200 people. The hotel possibly suffered 'sandwich' collapse because of the soft story. In this case, the first and second floors were made of reinforced concrete material while the third floor above them was made of steel material (Figure 5). The difference of stiffness between the two materials had caused the steel structures suffered structural failure due to poor detailing, and then they fell onto the lower concrete structures.

FIGURE 5. West Sumatra Earthquake in 2009, Hotel Ambacang suffered 'sandwich' collapse (source: <http://xa.yimg.com/kq/groups/17587015/808630997/name/Kerusakan+Gedung+-+GB+Padang.pdf>).

The case above can be minimized by creating the steel structure having the same stiffness as the stiffness of the concrete structure such as adding bracing and improving the

detailing quality (see Figure 6). However, this method can raise the construction cost because the steel construction is more expensive than regular steel and concrete structures.

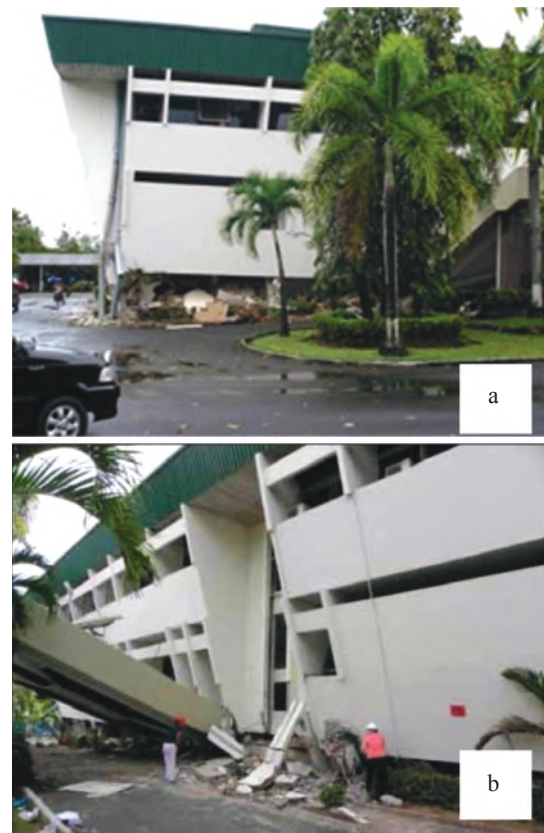
This building consisted of three floors and made of reinforced concrete. Soft story occurred on the first floor had caused the floor to collapse while the second floor above was relatively intact (Figure 7). The shape of the building, like reversed pyramid, had caused a weak story at the first floor. In addition, the quality of concrete was also inadequate.

FIGURE 7. West Sumatra Earthquake in 2009. The first floor of BAPPEDA Office collapsed, but the second floor above it was relatively intact (source: Wilkinson et al. 2012).

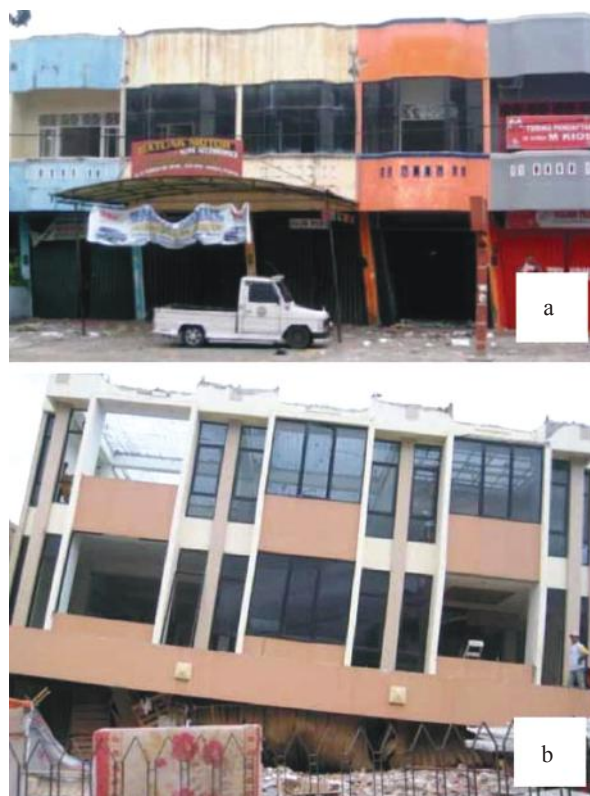
Ruko (rumah toko)/ a shophouse is a commercial building that dominates cities in Indonesia including in earthquake-prone cities such as Banda Aceh, Bengkulu and Yogyakarta. Generally they have typical square shape where the facade has rolling gates and large windows, and shophouse units are separated by brick walls and structures made of reinforced concrete. This condition makes the shop's transversal direction more rigid than its longitudinal direction. When there is earthquake's lateral shaking, the first floor experiences a 'sway mechanism' in the direction of the longitudinal axis. Inadequate column shear capacity which is worsened by the habit of planting utility pipes in the column (Figure 10b), lack of column ductility, and poor construction have caused the residual drift (Figure 9a). If the shophouse unit is single or less, the sway mechanism on the first floor can cause 'sandwich' collapse (Figures 9b & 10a).

FIGURE 9. West Sumatra Earthquake in 2009, a). Ruko/ shophouses undergoing residual drift, b). The first floor of the shophouses collapsed (source: Wilkinson et al. 2012).

The previous case can be minimized by increasing the stiffness of the first floor, that is utilized as a living space, with room's partitions from brick walls while the upper floor is utilized as commercial unit.

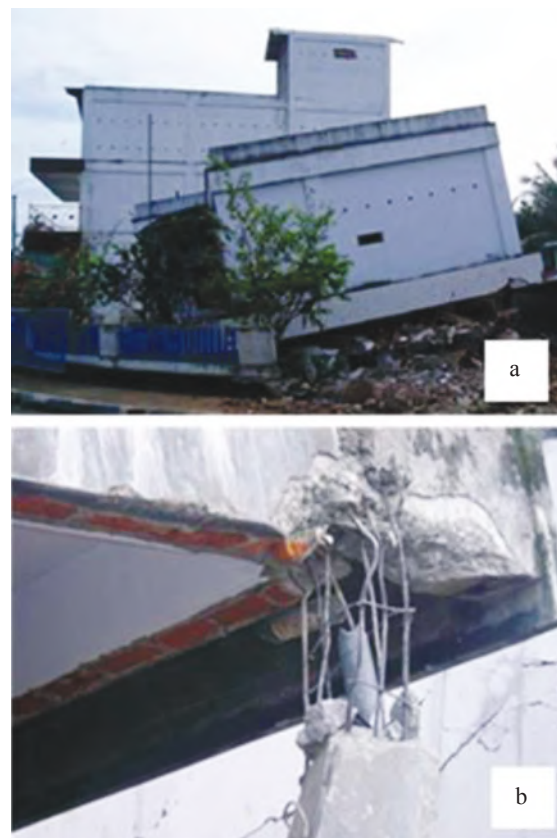
FIGURE 10. Bengkulu Earthquake in 2007, a). The collapsed shophouses, b). Planting utility pipes in the column (source: Boen 2007a).

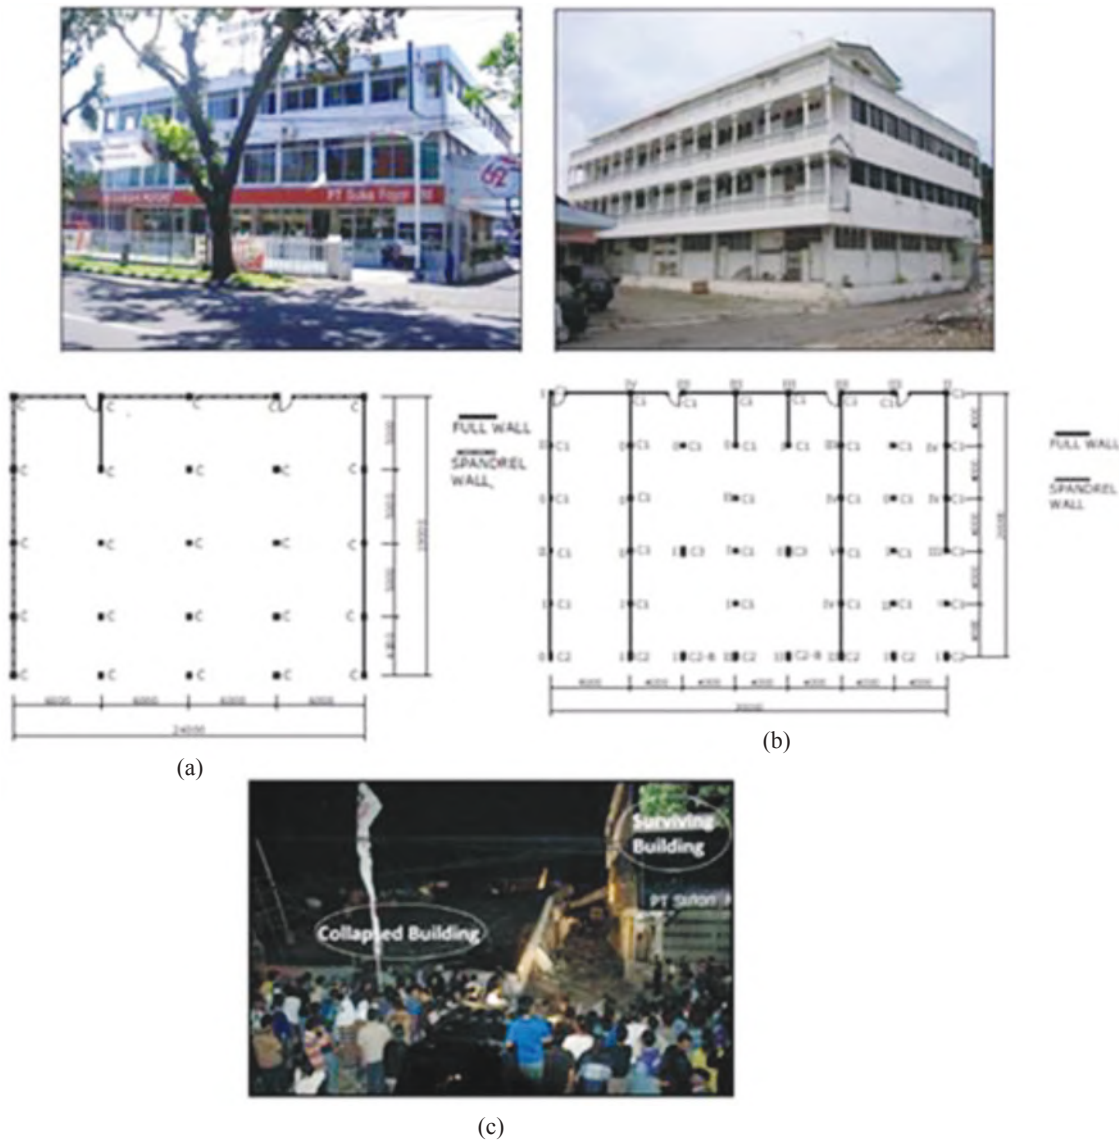
Motorcycle Show Room

Maidiawati (2013) investigated the effect of wall infill towards the soft story in buildings. The study was conducted in two showrooms buildings experiencing the 7.6 M_v scale earthquake on September 2007 at Padang. Although both showrooms had the relatively same shape, they experienced different conditions. The first showroom underwent 'sandwich' collapse (Figures 11a & 11c) while the second showroom still stood though suffering moderate damage (Figures 11b & 11c).

Maidiawati's dissertation concludes that the first showroom experienced 'sandwich' collapse condition due to the softstory on the first floor. This condition is caused by the difference of wall infill where the first floor was only 0.15% while the upper floor was more than 1%. This condition then created significant stiffness difference, so when a strong earthquake occurred, the first floor was not strong

enough to hold it. On the other hand, the second showroom still stood even though suffering moderate damage because the wall infill was more than ($>$) 1% in every floor and its distribution among the floors was relatively even. When the strong earthquake occurred, all the floors were able to collectively withstand it.

FIGURE 11. Padang Earthquake in 2007, a). The collapsed showroom, b). The surviving showroom, c). The picture of both collapsed and surviving showrooms (*source*: Maidiawati 2013).

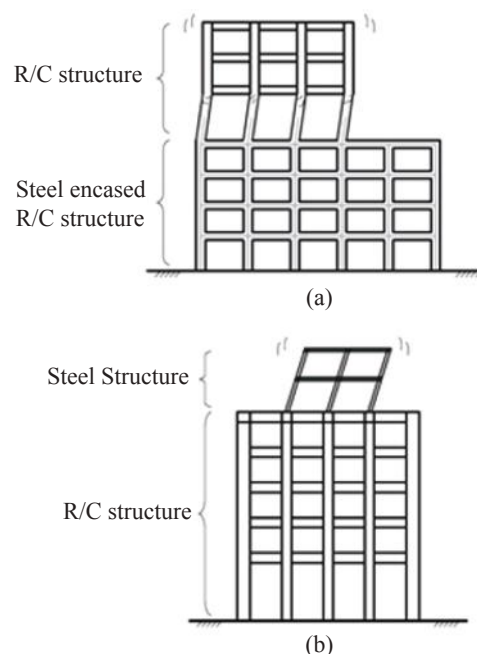
- Combining materials with different stiffness as the main structure of a building (Figures 12a & 12b). In figure 12b, parts of the building made of steel can still function as a service unit and not as a living unit.
- Inadequate structural ductility and poor construction.

FIGURE 12. Buildings having different materials can cause soft story (source: JIA and JASO 2012)
