# FAILURE INVESTIGATION OF A STEERING BEARING IN MATIC MOTORCYCLE 125 cc

Nur Aidi Ariyanto, Sri Nugroho, Rifky Ismail

**Abstract :** A Motorcycle is light vehicles that have a lot of systems that work together and link each other such as chassis system, power train system (engine), brake system, electrical system, suspension system, etc. Bearing is one among other supporting parts of a motorcycle. It's steering bearing and wheel bearing. Steering bearing is usually exchanged faster than wheel bearing. Steering bearing is a thrust bearing type that able to support axial force, transversal force and also impact force. Failure was happened in steering bearing because of miss assembling, overload carrying, bad road condition and lack of grease.

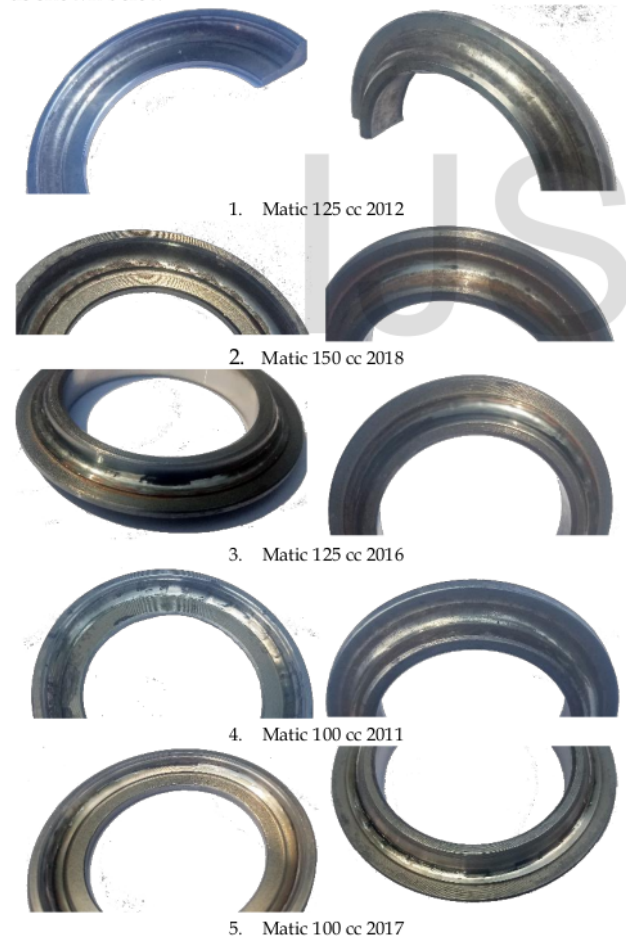
Fig. 4. Failed Steering Bearing several motorcycles.

Visual examination was carried out using a 3 Megapixel Camera, there were 5 motorcycle's steering bearing had been examine. The condition of steering bearings for each motorcycle as shown below

The result of the visual examination at specimens appears that there are some dent marks or fretting or false brinelling effect on the bearing raceways, generally caused by vibration.

At specimen number 4, the dent marks are severe. These happen because of the accident of this motorcycle that bent the front shock breaker.

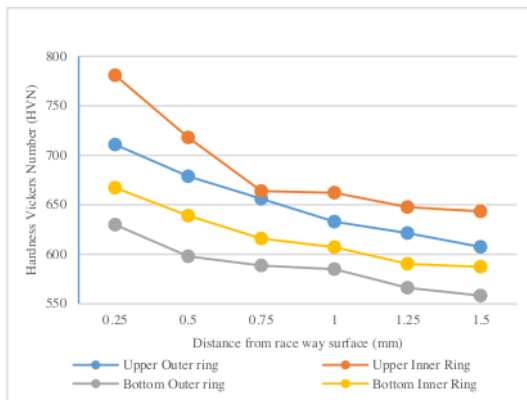
Fig. 5. Chart of micro hardness for New Bearing.

The result of microhardness measurements made into a chart, shown in Fig. 5 and Fig. 6.

Distance from race way surface	Upper Outer ring	Upper Inner Ring	Bottom Outer ring	Bottom Inner Ring
0,25	710,83	780,80	629,77	667,27
0,5	678,67	717,93	597,87	638,97
0,75	656,13	663,83	588,63	615,90
1	632,97	662,20	585,03	607,13
1,25	621,37	647,73	566,17	590,27
1,5	607,50	643,33	558,20	587,40

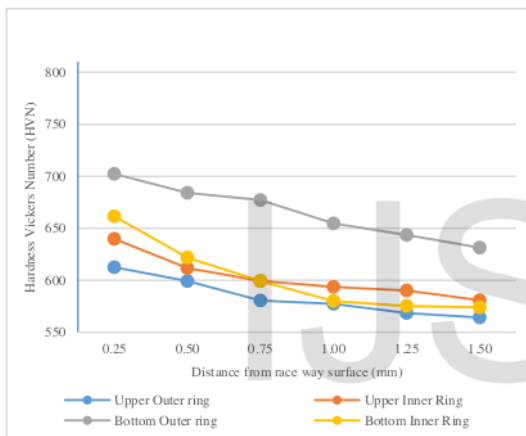
Fig. 6. Chart of micro hardness for Failed Bearing.

Distance from race way surface	Upper Outer ring	Upper Inner Ring	Bottom Outer ring	Bottom Inner Ring
0,25	612,5	639,7	702,2	661,4
0,5	599,3	611,7	684,0	621,8
0,75	580,6	599,3	677,0	599,3
1	577,3	593,6	654,6	580,0
1,25	568,4	590,1	643,6	575,3
1,5	564,2	580,8	631,3	573,9

Fig. 6 shows that there was a slight increase in hardness for the bottom bearing and there was a slight decrease in hardness for upper bearing. This may happen because of the difference force load between the upper and bottom bearing during operation for a long time period.
