Changes in the face of cultural heritage buildings due to revitalization: a case study of Fort Willem II Oenarang

Djoko Indrosaptono*, Alfianadi Agung Setiyawan, Tri Susetyo Andadari

*Department of Architecture, Faculty of Engineering, Diponegoro University, Semarang, Indonesia
Jl. Prof. Soedarto, SH, Kampus UNDIP Tembalang, Semarang, Indonesia 50275*

Keywords: *revitalization, building facade, Benteng Willem II Oenarang*

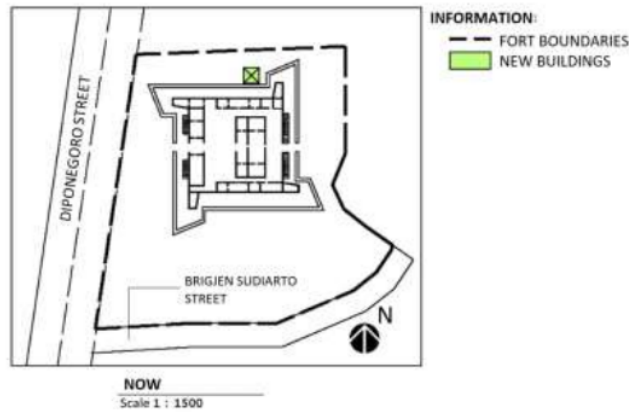
The building plan has hardly changed. Only the right wing has changed, from the old closed building (see Figure 3) to semi-open buildings, and the addition of new buildings on the left wing as shown in Figure 1 above.

Figure 3. Past (a) and Present (b) Plan of Willem II Fortress in Oenarang (Doc. Author, 2020)

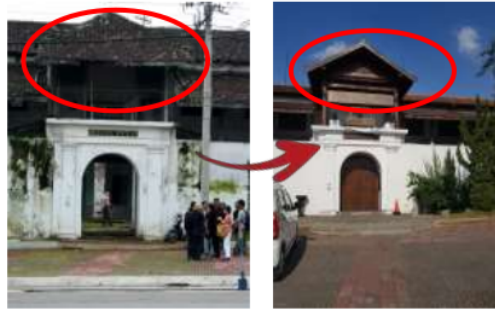
Apart from building plans, another thing that has changed in the revitalization of Fort Willem II Oenarang is the building facade. From the front view, there is a clear change in the shape of the tile slope as shown in Figure 4. The original building (left), the horses that stand out in the middle are covered with tiles, while after revitalization (right) the center of the roof has horses. -a horse with an upright direction, which is left open from the front with the addition of several ornaments, including the addition of the identity of the Indonesian Republic Police as a symbol of building ownership. In addition to the front roof, the rear roof of the building has also experienced a quite dominant change, namely changing the shape of the roof from a pyramid pattern to a straight pattern.

Figure 4. Roof Changes on Building Facades (Doc. Author, 2020)

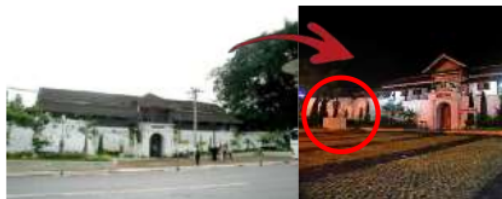
The addition of ornaments to provide additional value for the new function of the building, namely the fort as an icon of the city of Ungaran, can be seen on the outside of the building in the form of additional signage in the form of a signboard and the addition of a statue of a Dutch warrior on the left in front of the main gate (see Figure 6).

Figure 6. Addition of Statues and Signage to the Fortress Building (Doc. Author, 2020)

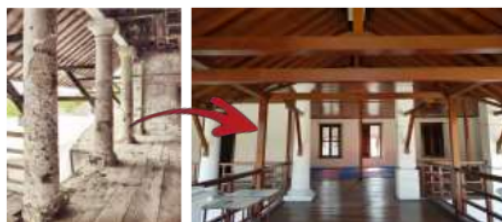
The column shape as the main structure of the building has also undergone changes, due to its long age and severe damage. Unfortunately, the repairs were not in accordance with the original condition of the building. So that the shape of the column is not the same between the right column and the left column and does not match its originality. The original column is cylindrical while the new column has a box section (see Figure 7).

Figure 7. Changes to the Structure of the Fortress (Doc. Author, 2020)

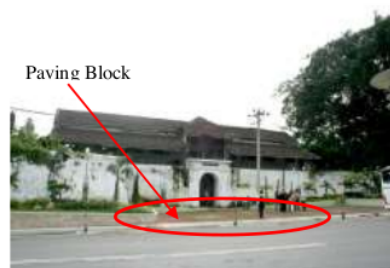
Another physical form that has clearly changed is the loss of the perimeter ditch that was used as a safety measure, in accordance with the function of the building as a fort as shown in Figure 8. This occurred as a result of the revitalization of the Willem II Fortress building as a tourist area which of course requires open land for parking, and garden.

Figure 8. Changes to the Environment Outside the Fort Building (Doc. Author, 2020)

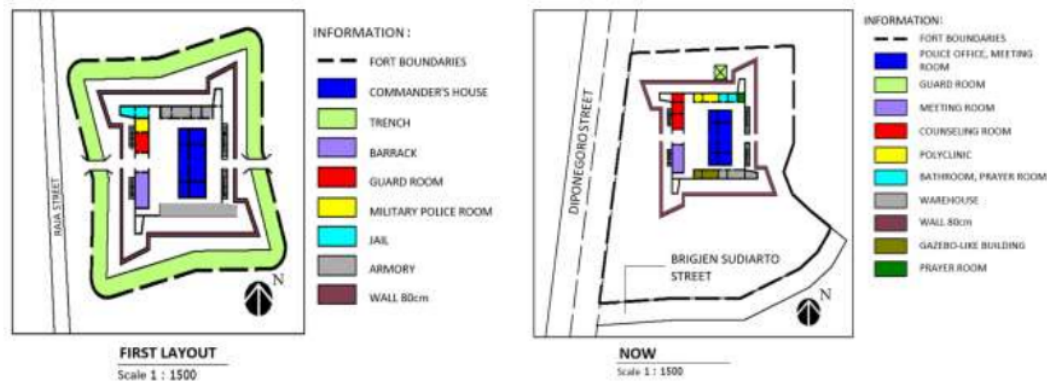
If one examines the purpose of building revitalization so that the building can provide benefits both from an economic and social perspective, it is clear that the Willem II Fort building has changed the function of each room as shown in Figure 9 below.

Figure 9. Functions of Early and Current Rooms of Fort Willem II Oenarang (Doc. Author, 2020)
