Failure Analysis of a Cracked Gas Compressor

Abstract—Cracked Gas Compressor (CGC) serves as the vital core of the Olefin plant. However, one of the leading companies in Indonesia, which employs CGC, faces the challenge of high vibration in both low-pressure (LP) and medium-pressure (MP) casings. This phenomenon is very important to overcome, because it may cause losses of thousands and even millions of dollars per day for the Company when there is a system failure. Vibration levels in MP casing have escalated from 13.8 μm to 39 μm, and LP compressor vibration has abruptly risen to 52 μm from 12 μm. Therefore, this study aimed to investigate the underlying causes of this high vibration in CGC. To analyze vibration issue, the Process Information (PI) and *System1* software were employed. The result showed that the fouling of the rotor was the primary source of vibration in MP casing, while mechanical damage to rotating parts was responsible for vibration in LP casing. It is recommended to implementation of wash oil injection to reduce fouling and utilization of water injection to reduce compressor discharge temperature.

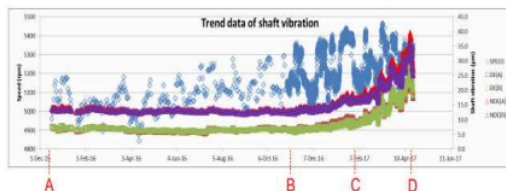
TABLE I.   VIBRATION VALUES MONITORED AFTER THE 2015 START-UP

|	Merasurement period		Speed	DE		NDE	
				275 A	275 B	274 A	274 B
A	Comissioning	Dec 2015	4961 rpm	7.7 μm	7.8 μm	14 μm	13.8 μm
B	Start increasing shaft vibration	Nov 2016	5136 rpm	6.5 μm	6.6 μm	13 μm	12.7 μm
C	Discussion with vendor	Feb 2017	5104 rpm	8.7 μm	8.3 μm	16.8 μm	16.1 μm
D	Speed The highest shaft vibration	April 2017	5292 rpm	26.8 μm	28.3 μm	39.6 μm	36.6 μm

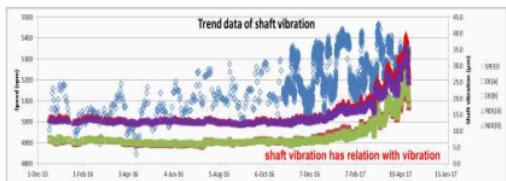
Fig 2. Trend data of shaft vibration related to Table I.

In April 2017, there was a significant increase in vibration in MP casing, specifically from 13.8 μm to 39.00 μm. The Table I shows vibration values monitored after the start-up in 2015.

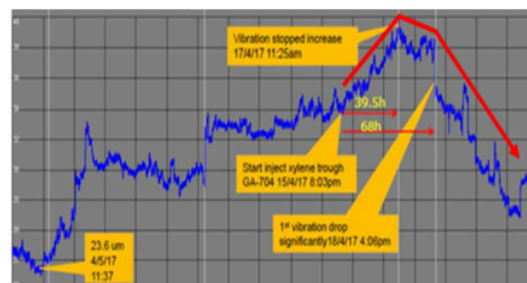
Fig 6. Trend of shaft vibration during wash oil injection.

Fig. 6 provided evidence that the addition of wash oil could effectively reduce vibration. According to the phenomena that occur on the graph, it is highly likely that the problem in MP casing is primarily caused by fouling in the impeller area.

To avoid fouling, two improvements were implemented at petrochemical plant. These improvements were as follows:

- Increase the capacity of wash oil injection: Upon reevaluation, it was determined that the installed wash oil capacity in the field fell short of the required amount by the licensor. During the revamping process, recalculating the wash oil requirement was overlooked.
- Reduce the discharge temperature by using water injection: Although compressor could inject water for gas temperature reduction, this particular company had not installed the necessary facilities. This caused the discharge temperature in stage 3 to exceed 88°C, leading to polymerization issues within MP casing.

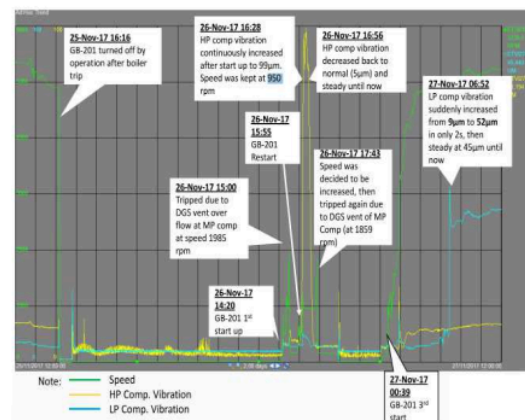
Fig 7. Chronology of vibration increase in LP casing.

Based on analysis, it was discovered that bypassing the vent flow was not dangerous. When the flow still exceeded the normal threshold during regular speed, it was recommended to turn off system and conduct further investigation. On the third attempt, compressor operated correctly, but after 1 minute at its normal speed, vibration in LP casing significantly increased to 52 μm (see Fig. 7).

After analyzing the preliminary data collected in LP casing, a why-why analysis for the problems, which occurred in this casing was presented. From the data in Table 3, vibration observed in LP casing was associated with rotor imbalance. Consequently, the following factors were taken into consideration:

While sudden damage unrelated to wash oil injection could not be ruled out, there remained a possibility of damage occurring in the above-mentioned areas. However, confirming the likelihood of such damage could only be achieved during the upcoming 2019 Turn Around Maintenance (TAM). Based on this condition, it was recommended to prepare replacement parts for these potential issues during TAM 2019.
