# Damage Stability Study of A 500 DW Ro-Ro Ferry Vessel

## Damage Stability Study of A 500 DW Ro-Ro Ferry Vessel

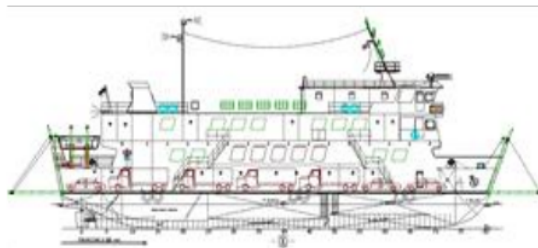
**Figure 2. Sample General Arrangement of the 500 DWT Ro-Ro Ferry**

The 500 DWT Ro-Ro ferry ship comprises the following payload capacities: 7 units of sedan cars, 12 units of trucks, 202 passengers, and 18 crew. The fuel tank is on a double bottom located in front of the engine room bulkhead with a capacity of 58 tons. The freshwater tank on the double bottom is located in the midship with a capacity of 32 tons. General Arrangement of the 500 DWT Ro-Ro Ferry are shown in Figure 2.

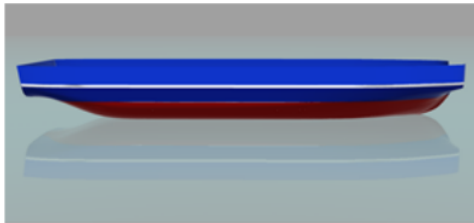
Figure 4. Sample Model of the 500 DWT Ro-Ro Ferry

The perspective shape of the redrawn results shows the shape of the stomach. The hull has a monohull shape, demonstrating an outstanding depth that produces significant buoyancy for passenger-type ships. Sample Model of the 500 DWT Ro-Ro Ferry are shown in Figure 4.

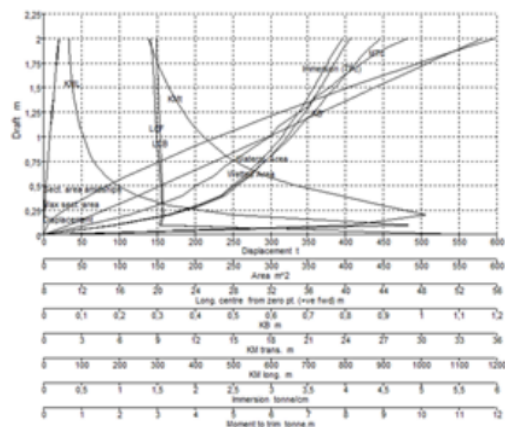
Figure 5. Hydrostatic Graph of the 500 DWT Ro-Ro Ferry

The following characteristics of the ship can be observed from the hydrostatic graph: the value of keel buoyancy, water surface area, longitudinal center buoyance, tons per centimeter, and displacement. The assessment results of ship characteristics are in accordance with the type of ferry ship. Hydrostatic Graph of the 500 DWT Ro-Ro Ferry are shown in Figure 5.
