# Sustainability of Traditional Markets Post-Revitalization: A Case Study of Bulu and Peterongan Markets in Semarang, Indonesia

by Suzanna Ratih Sari, Nindita Kresna  
Murti, Muhammad Fariz Hilmy

Department of Engineering, Architecture Department, Diponegoro University, Indonesia

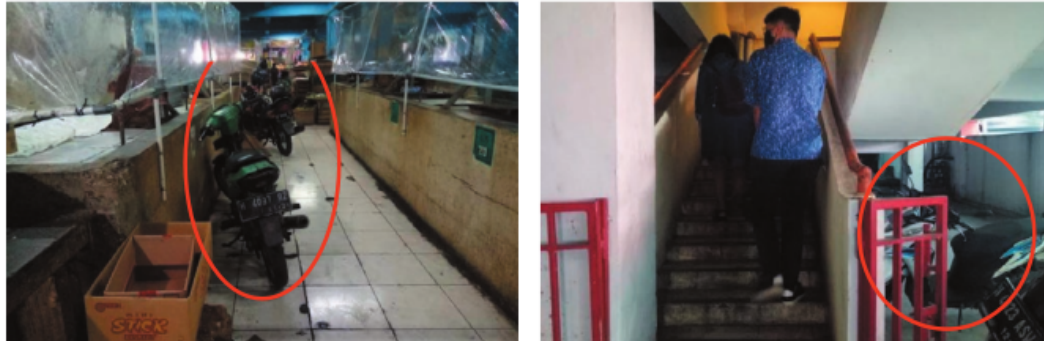
Figure 12. Customers park vehicles right in front of the stalls (left) and customers park in the basement then go up to the next floor by stairs (right).

Frequent customers of Bulu Market undoubtedly know the appropriate routes to get to the market but it will be difficult for those visiting for the first time due to the lack of clear directions to enter the market area and park vehicles. Some of the vehicles were observed to have been parked up to the 2nd and 3rd floors as shown in Figure 12 even though they are not allowed at upper floors but those with the experience of the terrain usually move to these floors while those visiting for the first time usually park in the basement. This usually leads to inconven-

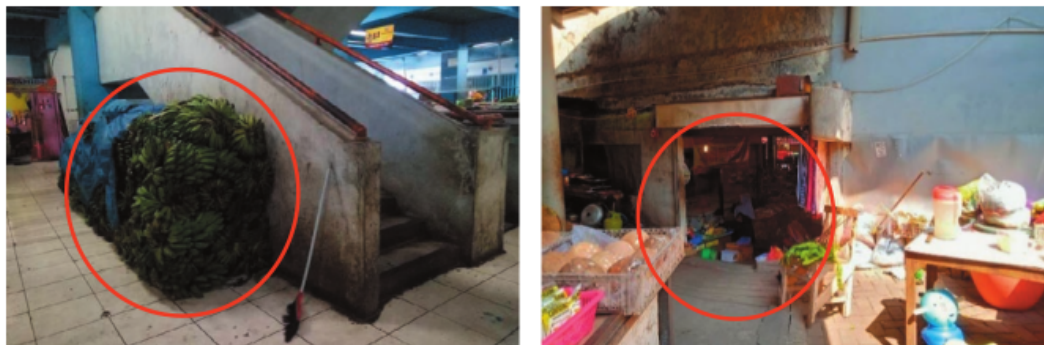
Figure 13. The condition of goods placed in the corridor of Bulu Market (left) and Peterongan Market (right).

The goods in both markets are not treated hygienically with those in Bulu market observed to be displayed on the floor of the street corridor and not neatly arranged in the traders' stalls, thereby, creating a blockage to the customers' path as shown in Figure 13. The same was also discovered at Peterongan Market with the traders recorded to be putting their goods in the corridor due to the inability of their stalls to accommodate the number of goods they have as also indicated in Figure 13. These, however, make the customers consider their options on buying the goods and this is one of the non-physical conditions determining customers' convenience in selecting traditional markets for transactions.

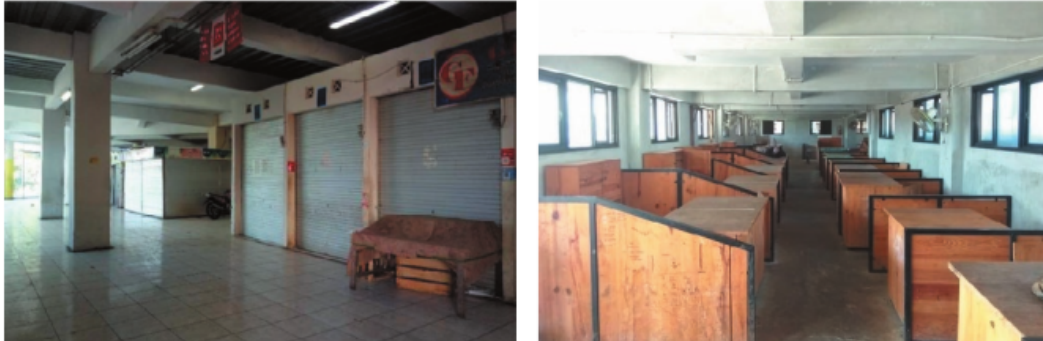
Figure 15. Stalls atmosphere at Bulu Market (left) and Peterongan Market (right) post revitalization.

The atmosphere and the environment of the market were discovered to have become lifeless due to the lack of activities. Traditional markets are generally usually alive due to the crowd provided through the transaction between the traders and customers and this means they both depend on each other to make the market a lively place. Meanwhile, the traders' environment also affects customer behaviour (Susilo, 2012) and this means the absence of customers is due to the inappropriate management of the markets and their environment. The customers are also not willing to visit empty stalls as shown in Figure 15 but they prefer crowded stalls, close access, without upstairs, affordable prices, and friendly service. The inability of a market to satisfy any of these factors usually leads to the emptiness of the stalls and this means the traders need to find other places supported and visited by more customers.
